Building Evolution

Philip Walker House
A Preserve Rhode Island property

STUDY HOUSE
ARCHITECTURAL GUIDE

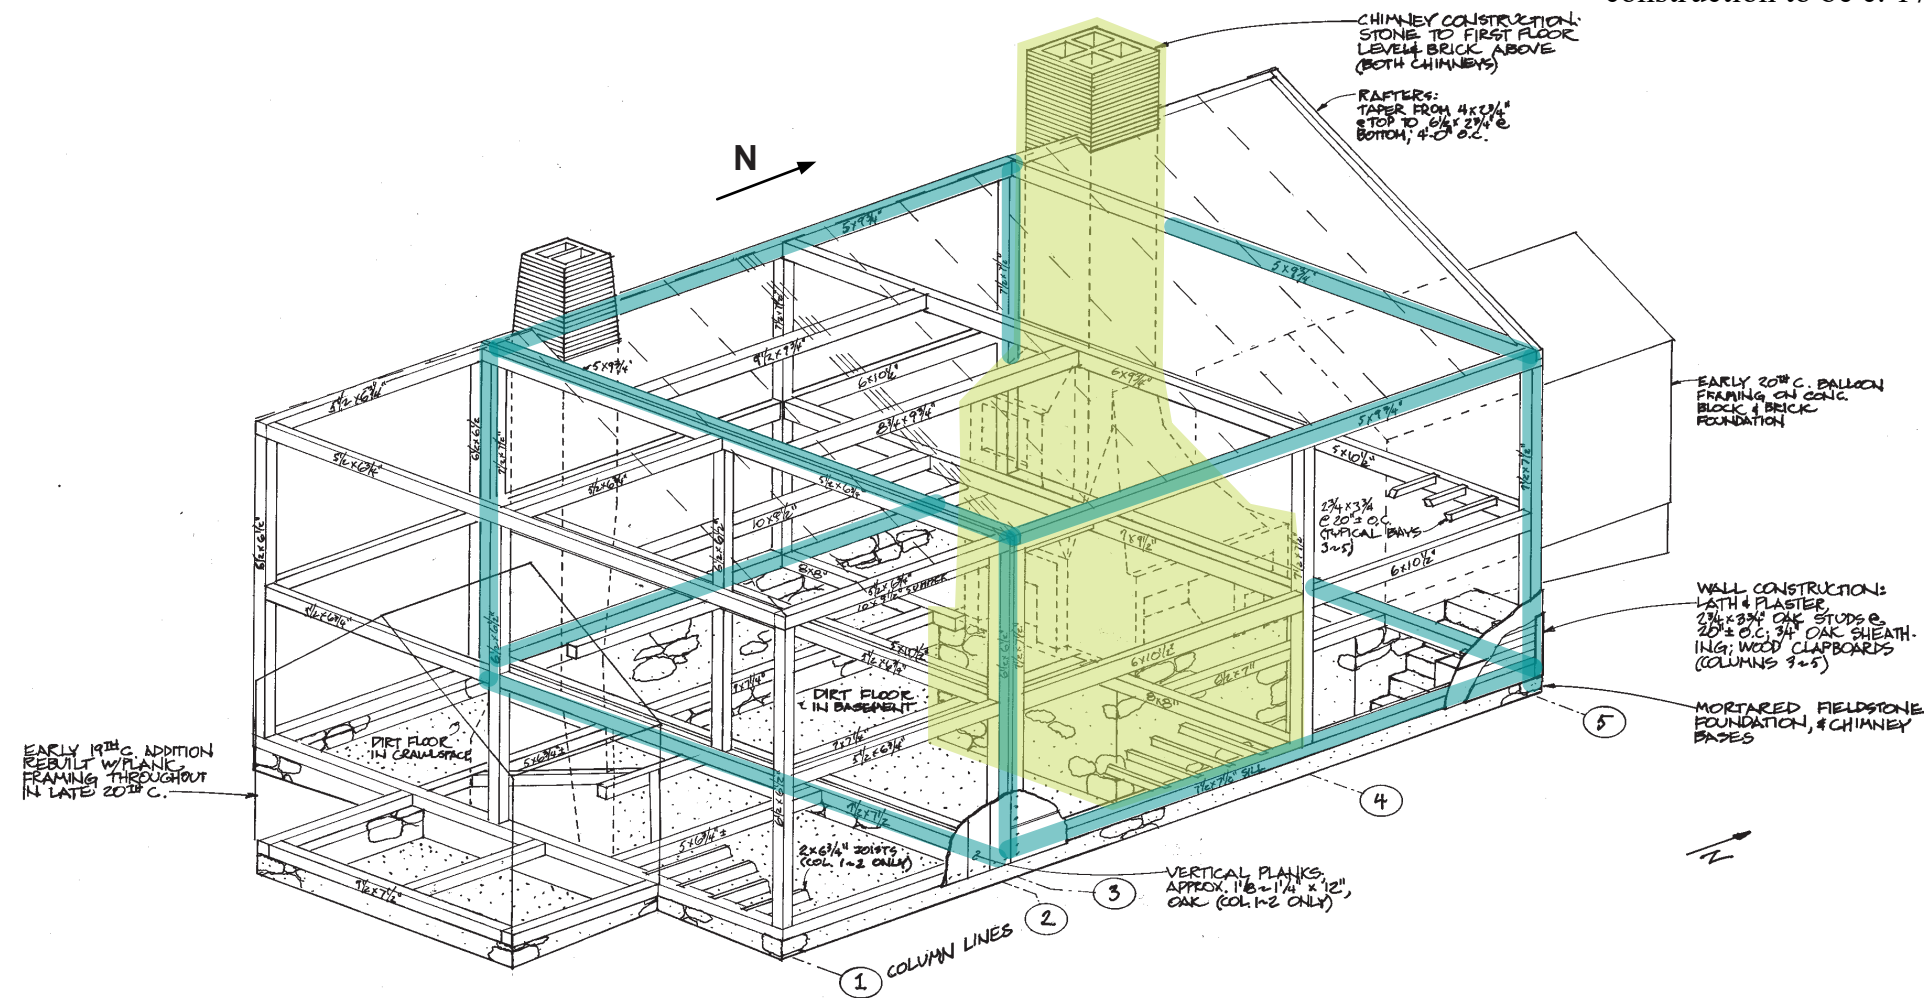
The original 1724 section of the house (**highlighted**) departs from the typical square-plan framing because it lacks intermediate posts on the north and south walls. In other respects, such as the presence of summer beams only in the parlor and the chamber above, the framing is consistent with square-plan practices.

The framing is of vertically sawn oak timbers, concealed in beaded casing, yet lacking chamfered edges and whitewash, decorations common to the 17th and early 18th century. This points to a date of construction closer to the 1740's, however dendrochronology evidence proves the date of construction to be c. 1724, making this the oldest known sawn-timber frame house in Rhode Island.

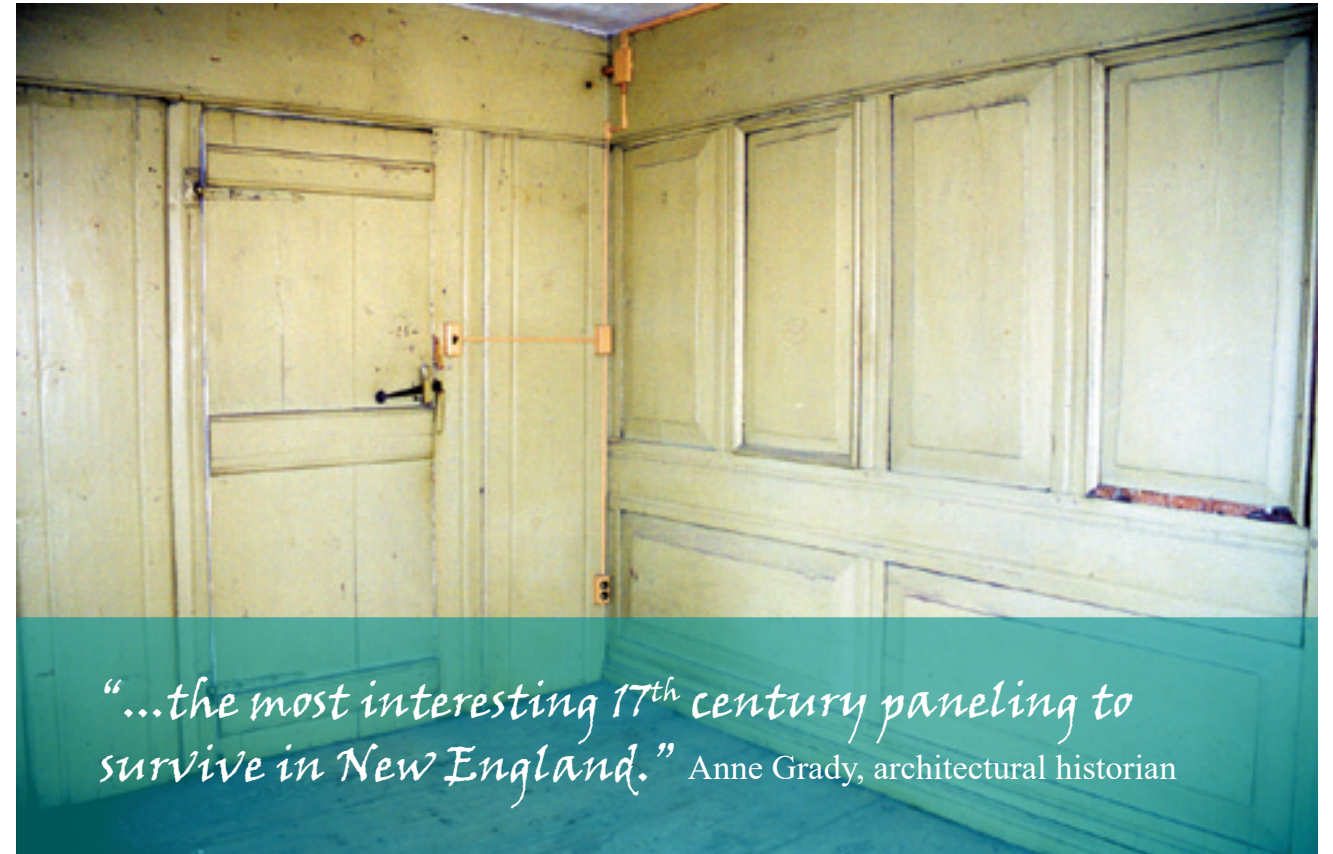
Stylistically, the panels date to late 17th or very early 18th century with a mixture of 17th century vertical sheathing, wide bevels, unusual homemade groovings, and a provincial version of the stile-and-rail paneling that repeats in the sheathing detail.

- Vertical portions of the paneling are shorter than current room, with a beaded board along the top added to fill in the missing portion
- The relationship of the paneling to the windows is awkward, coupled with a discontinuity of wall finishes that change arbitrarily from paneling to sheathing midway along the east wall
- The paneling on part of the east and south walls is typical of shadow or crease-molded vertical sheathing, which was popular for fireplace walls and not often found on outer-walls as it is here
- The plan and size of the room does not relate to the floor plan below or to the framing of the house, which suggests the size of the room may have been altered to accommodate the paneling

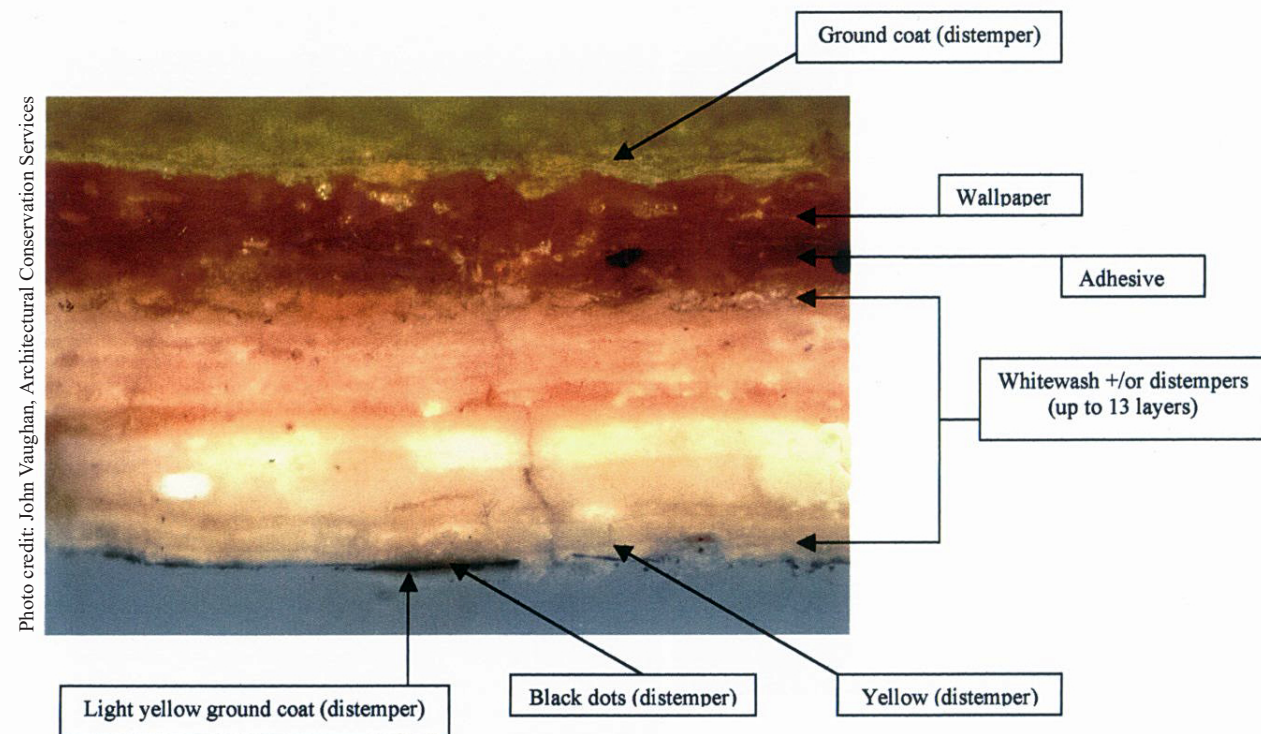
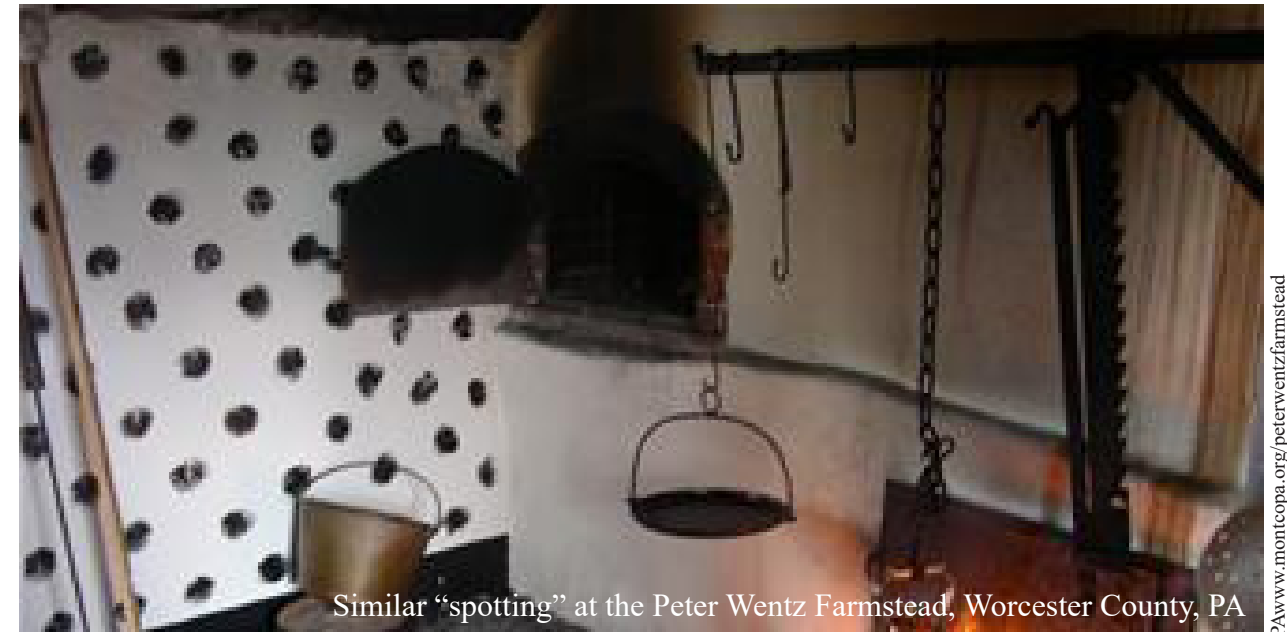
Evidence of whitewash and spotting can be seen in the China Closet (accessed through the dining room in the 1780 addition).

- Created using a carrot or turnip cut as a stamp to the desired diameters and applied over a light yellow ground coat
- Paint analysis concludes dots were applied to the base coat and are under up to thirteen layers of whitewash and wallpaper indicating the dots were an early treatment

- Not conclusively dated
- Technique was used throughout the 18th century so the dots could correlate to the 1724 original structure or the 1780 addition

- Reconfiguration of the china closet over time makes dating difficult
 - During construction of the new addition, and when the new east entry door (current front door) was installed, a passageway to the southeast room (dining) was created by cutting off the easternmost four feet of the small room south of the stairs. The truncated small room was thereafter accessed from the southeast room in the addition.
 - Architectural evidence suggests that the door to the southeast room and its casing were cut through at the end of the passageway when the addition was built
 - Red dots were discovered more recently over the door in the passageway, but have not been analyzed.
 - Hand-wrought nails in the passageway suggest the dots may have been applied around the same time as the 1780 addition

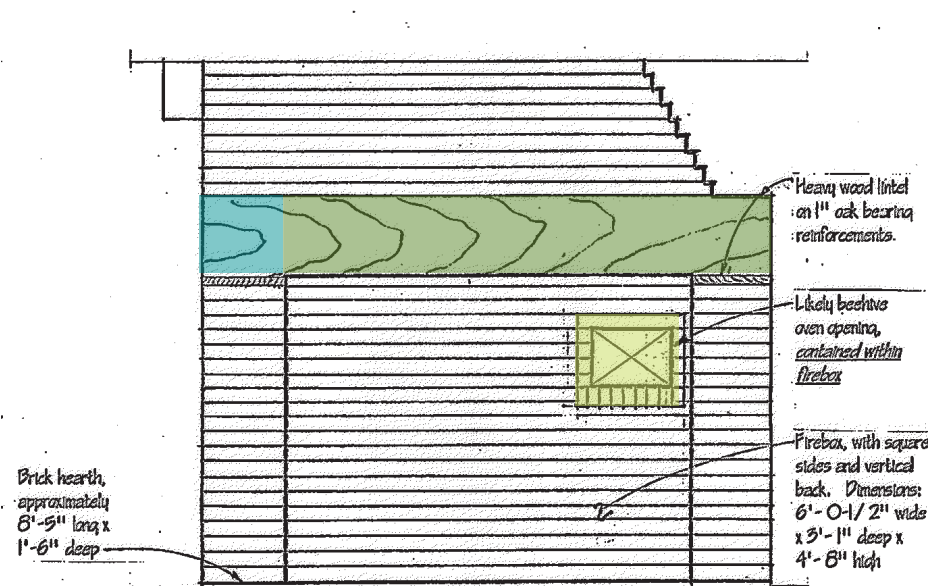
1st. PERIOD: ca. 1725 to ca. 1770
SCALE: 1/2" = 1'-0" (ALL)

Upon construction, the fireplace mantel was a simple brick and lintel construct. Wood grain evidence (highlighted) of the original oversized lintel (highlighted) can be seen in the remaining mortar on the left side of the fireplace. A beehive oven (highlighted) was constructed at the rear of the firebox (the original dome can be viewed to the right down the hallway). The large square-sided firebox was dangerous and inefficient, leading to the modifications in the next period.

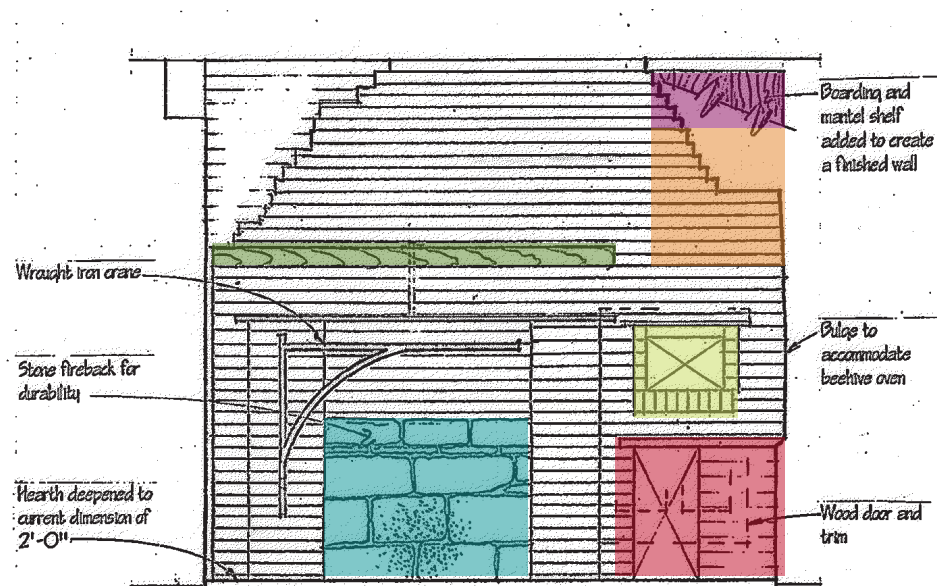
2nd PERIOD: ca. 1770 to ca. 1850

Circa 1770, the firebox was modified to remove the dangers associated with accessing the beehive oven beyond the burning hearth. The firebox was made smaller through the addition of a mortared-stone shelf (highlighted) and angled brick sides. The beehive oven was brought forward in front of the original to place its opening outside and to the right of the new firebox (highlighted). These modifications also reduced the size of the flue and allowed the use of a smaller lintel (highlighted).

These modifications were coupled with new decoration, adding wide-board panels over the mantel (highlighted) and finishing the beehive oven with a raised-panel door (highlighted). A herb drying cupboard (highlighted) was also added above the new beehive oven.

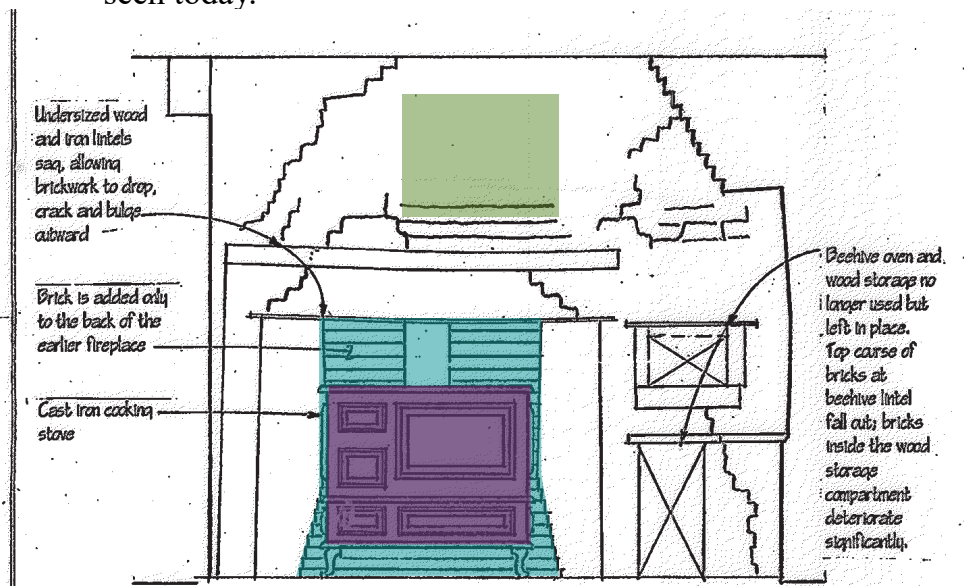
ca. 1850 to 2008

By 1850, greater efficiency was desired and the firebox was made smaller by adding new bricks above and in front, thereby enclosing the mortared-stone shelf (highlighted). Large stones were also mortared into place above the new, smaller firebox to shrink the size of the flue and decrease the draft that drew too much heat up the chimney (highlighted).

A cast-iron, wood-fired cooking stove (highlighted) was eventually installed in the firebox, was converted to gas by the 1890's, and was later abandoned in place in favor of the new kitchen-ell constructed in the early 20th century.

By the 21st century, all these modifications, coupled with the movement and settling of the house over time, caused significant structural cracks that necessitated the demolition of the chimney mass to the stabilized, reconstructed state seen today.

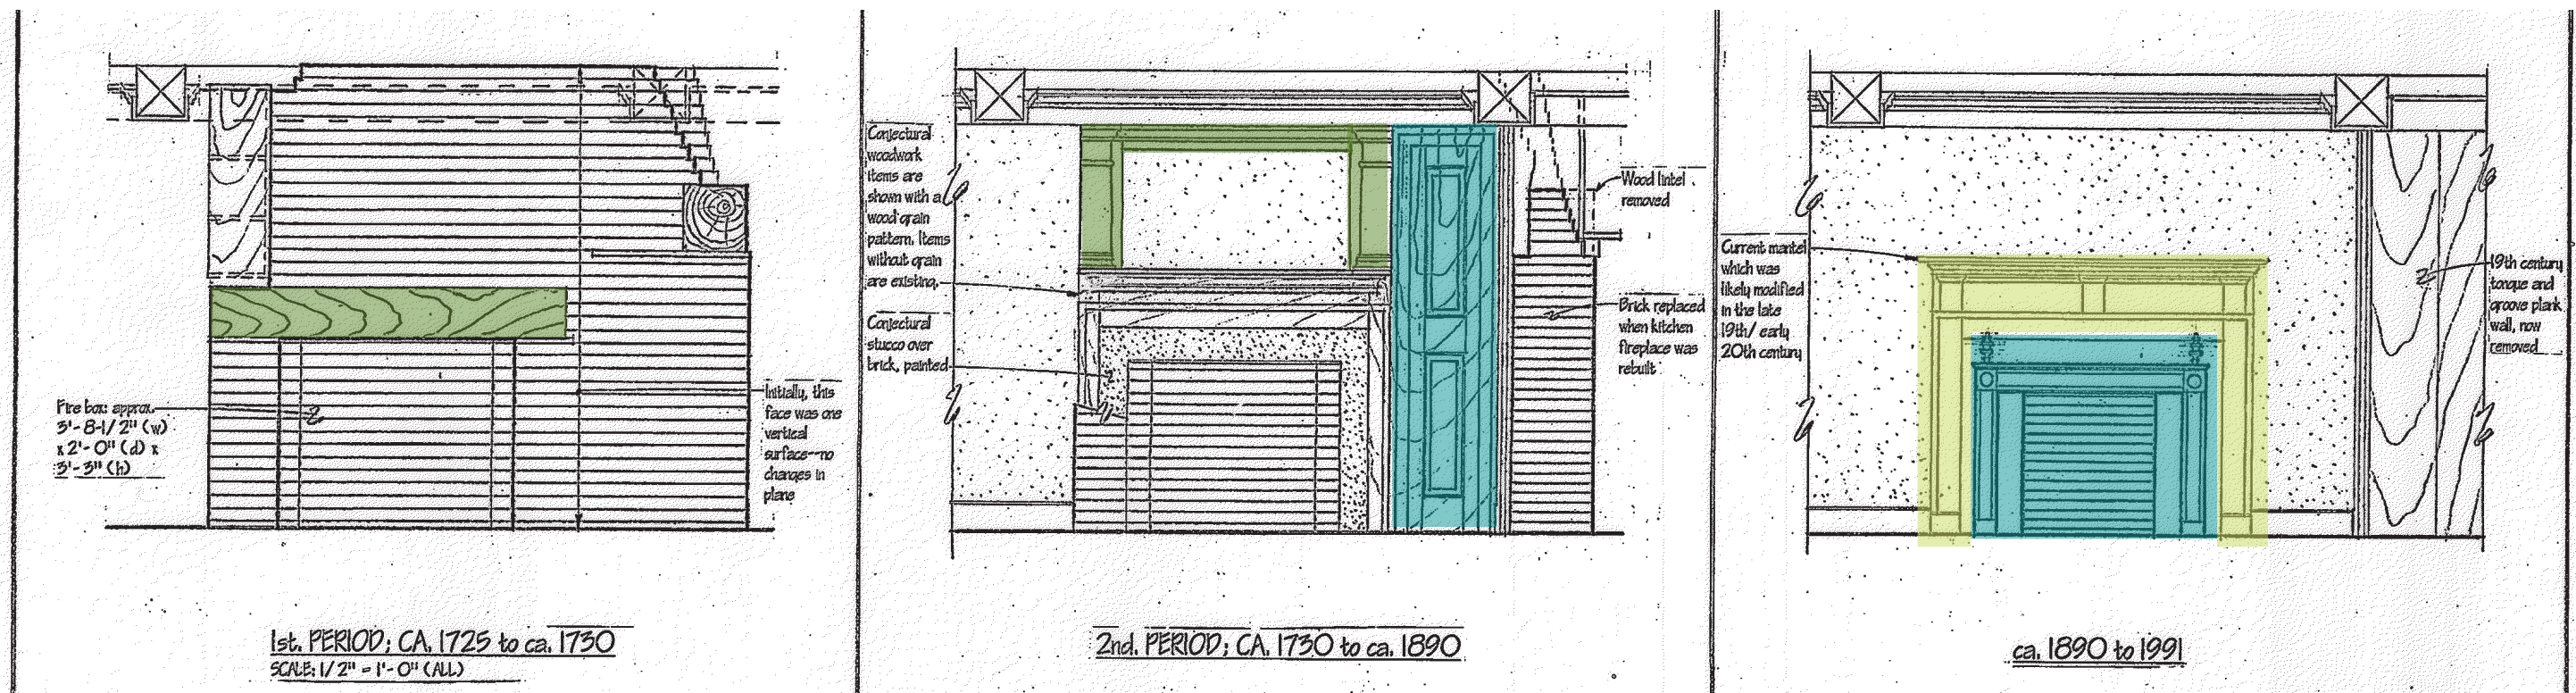
Upon construction, the fireplace mantel remained for a short period of time as a simple brick and lintel (highlighted) construct with minimal decoration and were soon finished in the popular Georgian style of the time.

An early Georgian chimneypiece was found behind the existing wall and paint evidence places it ca. 1730.

The two short pilasters, with scotia moulding for bases and a half-round fillet moulding for the necking (highlighted), have not been duplicated in other houses. However, there are similar chimney breasts with short pilasters in other Rhode Island houses.

This period also saw the addition of an enclosed storage cupboard (highlighted), which added the floor to ceiling paneling decoration common in the Georgian style.

In 1890, the great room was updated, removing the storage cupboard and paneling, and replacing the elaborate Georgian chimneypiece with a simple mantelshelf reflecting the revival period becoming popular in the late 19th century. This mantelpiece (highlighted) had a broad frieze, pilaster caps, central panel, and mantel shelf all nailed with countersunk hand-wrought nails. This was subsequently altered to accommodate a franklin-type cast iron stove insert (highlighted) set on the brick hearth, a modification that provided increased heat from fewer logs, an early energy-efficiency innovation.

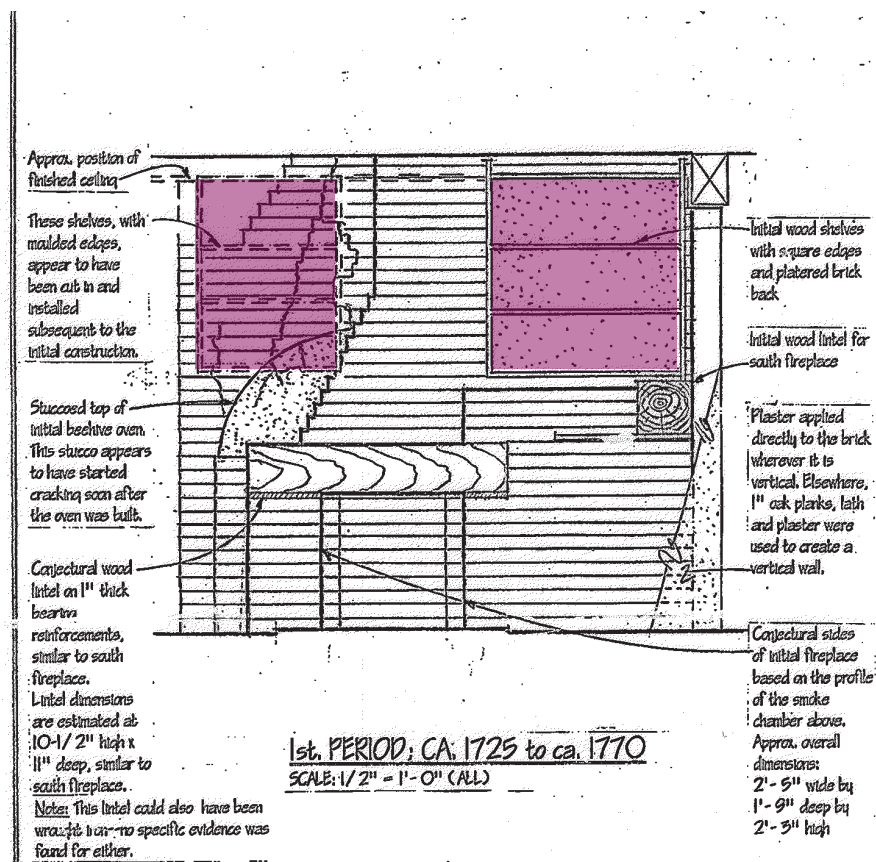
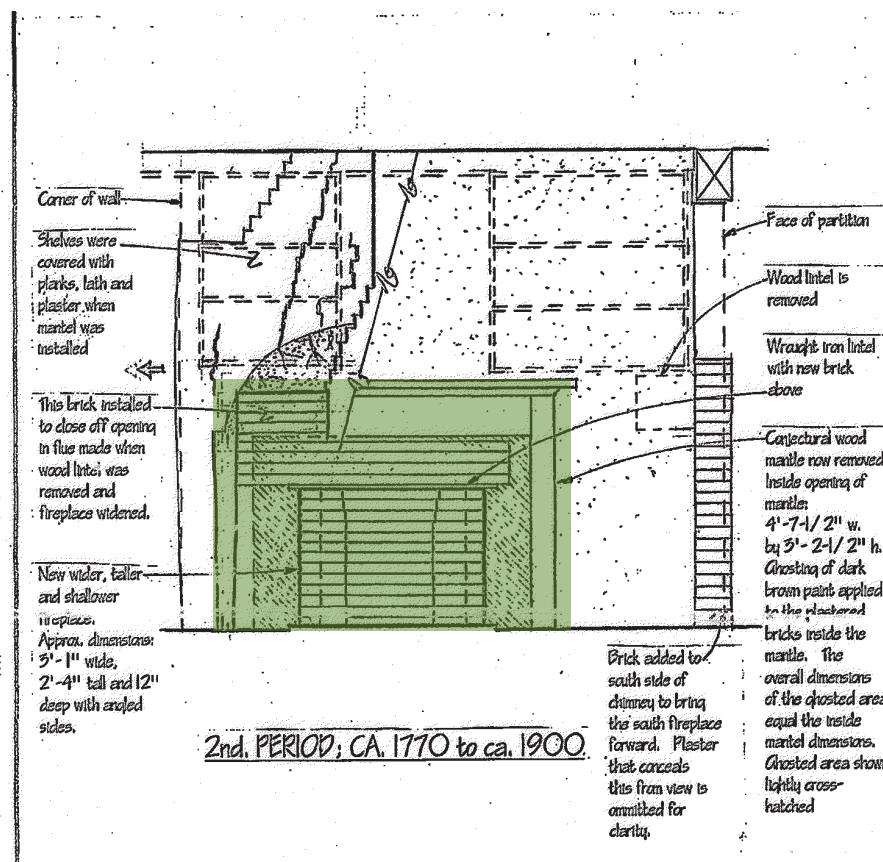
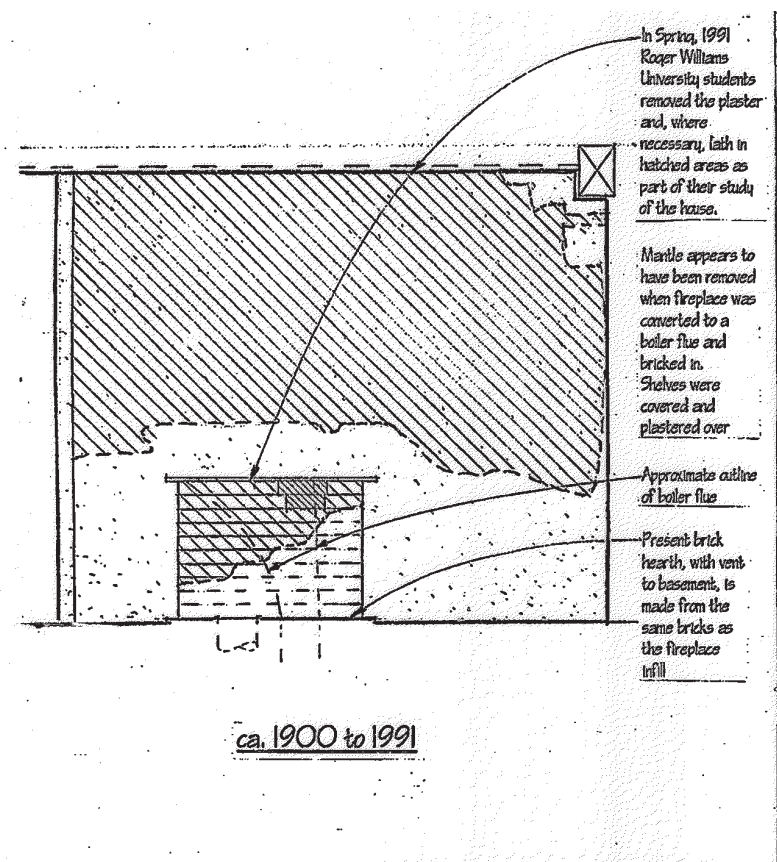
The Keeping Room was one of the most used rooms in the house, especially in winter. The small footprint of the room, coupled with the presence of the fireplace thanks to the square-plan design, meant this was the warmest room in the house and the easiest to heat. It therefore served as the primary, private living space where daily tasks such as sewing, correspondence and other household functions took place. Storage was generous with large and deep cupboards (highlighted) and decoration was minimal as it was not a public room.

As the Kitchen fireplace was modified, made safer and more efficient, the kitchen became more central to daily life and the Keeping Room took on a less functional role. Storage cupboards were plastered over and the firebox was widened to accommodate a new mantelpiece (highlighted). These updates likely established its use primarily as an office-space for the increasingly wealthy Walker family.

By the early 20th century, steam radiators were installed throughout the house to provide central heat, supplied by a gas, and later oil, boiler located in the basement. The Keeping Room fireplace was closed off to create a flue for the new heating system and the mantelpiece removed.
